RMI Ports Authority

2006 Pacific Aviation Directors Workshop

Majuro Runway Rehabilitation Project

Construction Progress

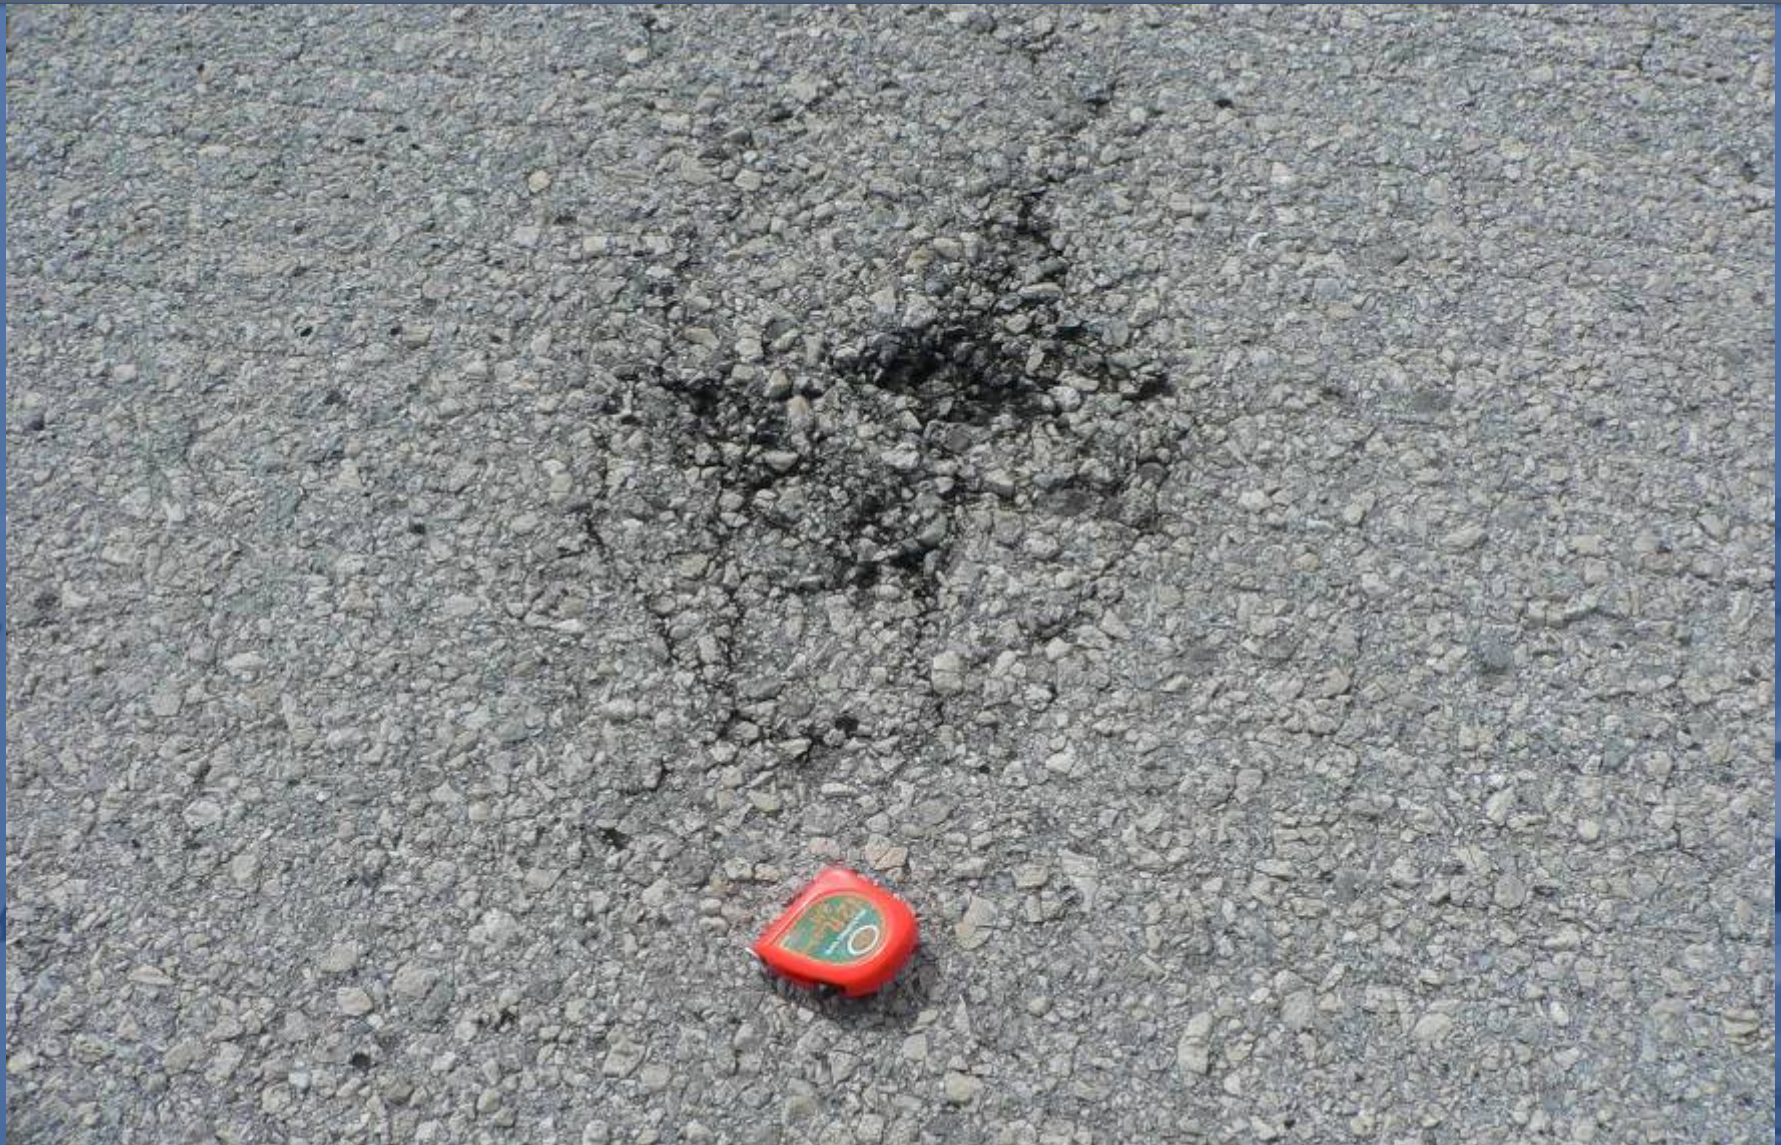
Surface Erosion on Runway 7

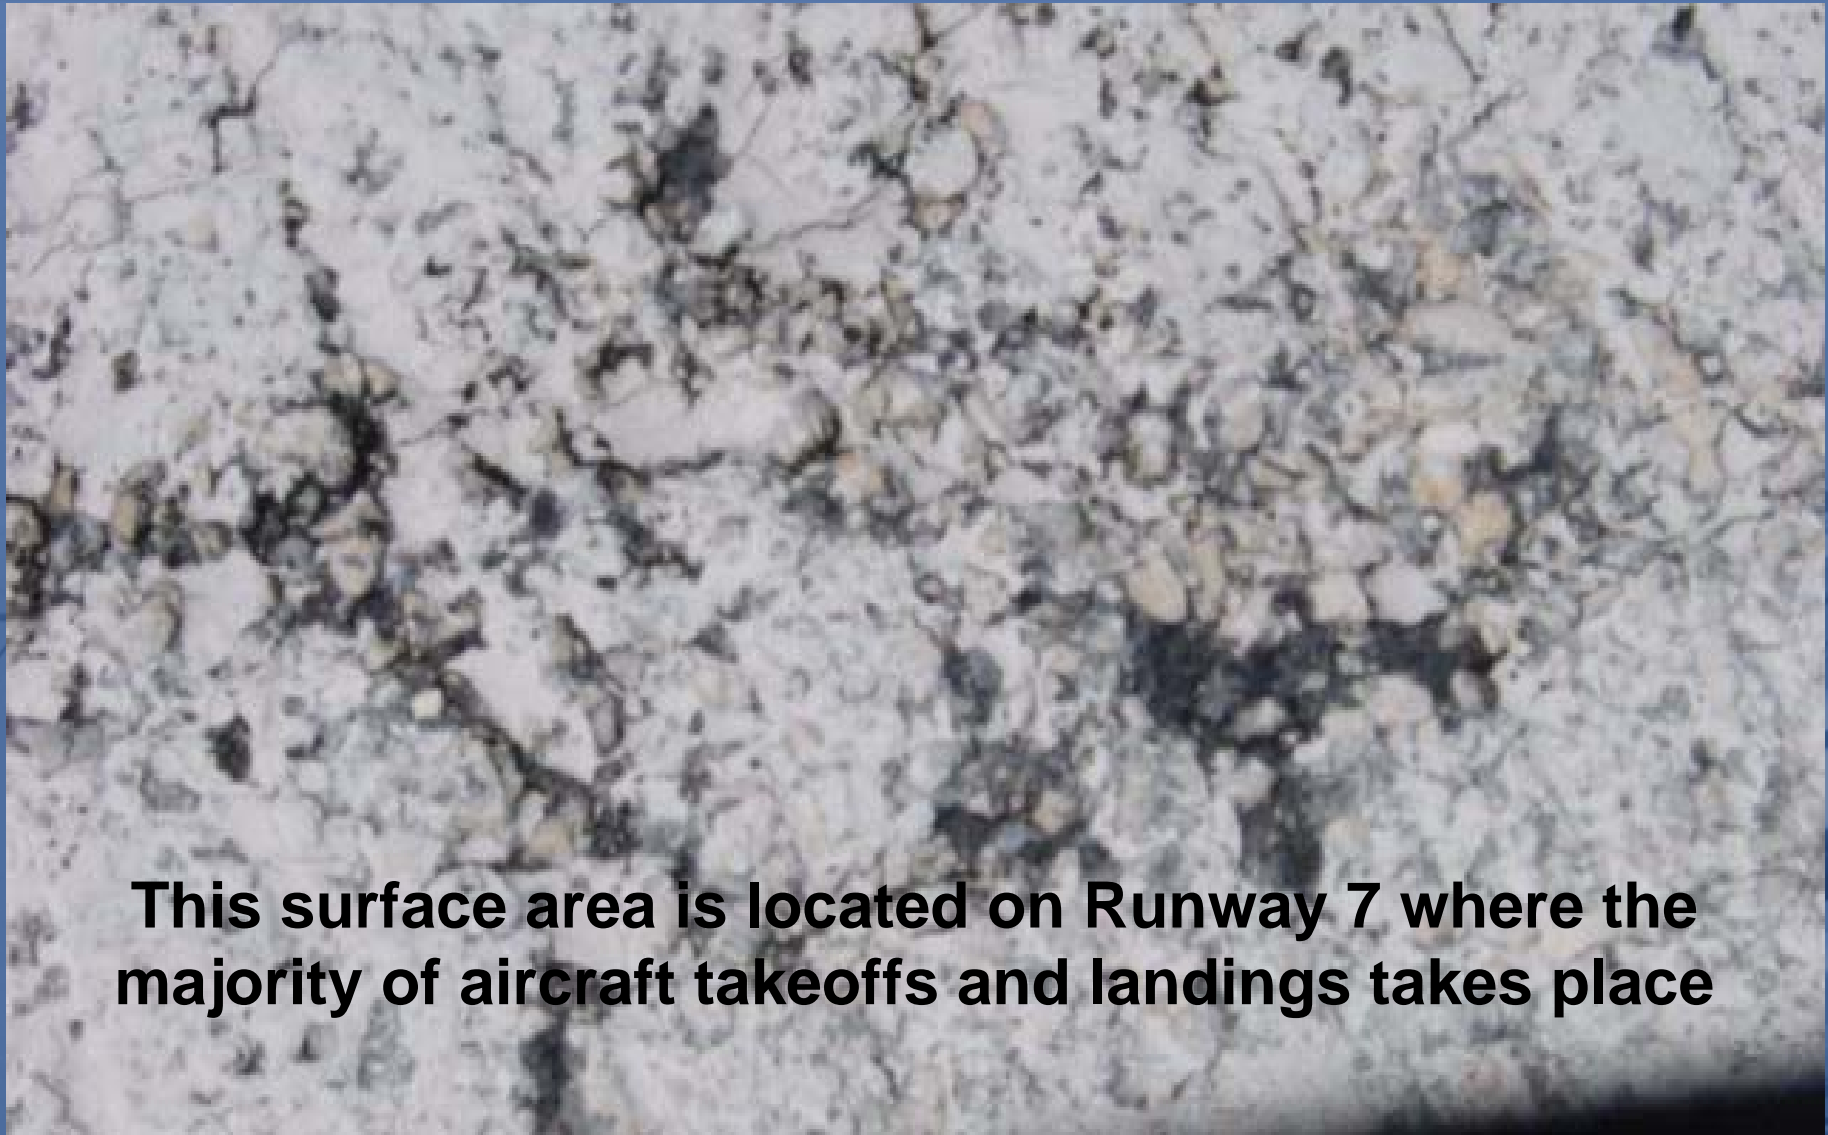
A runway centerline showing signs of raveling and weathering

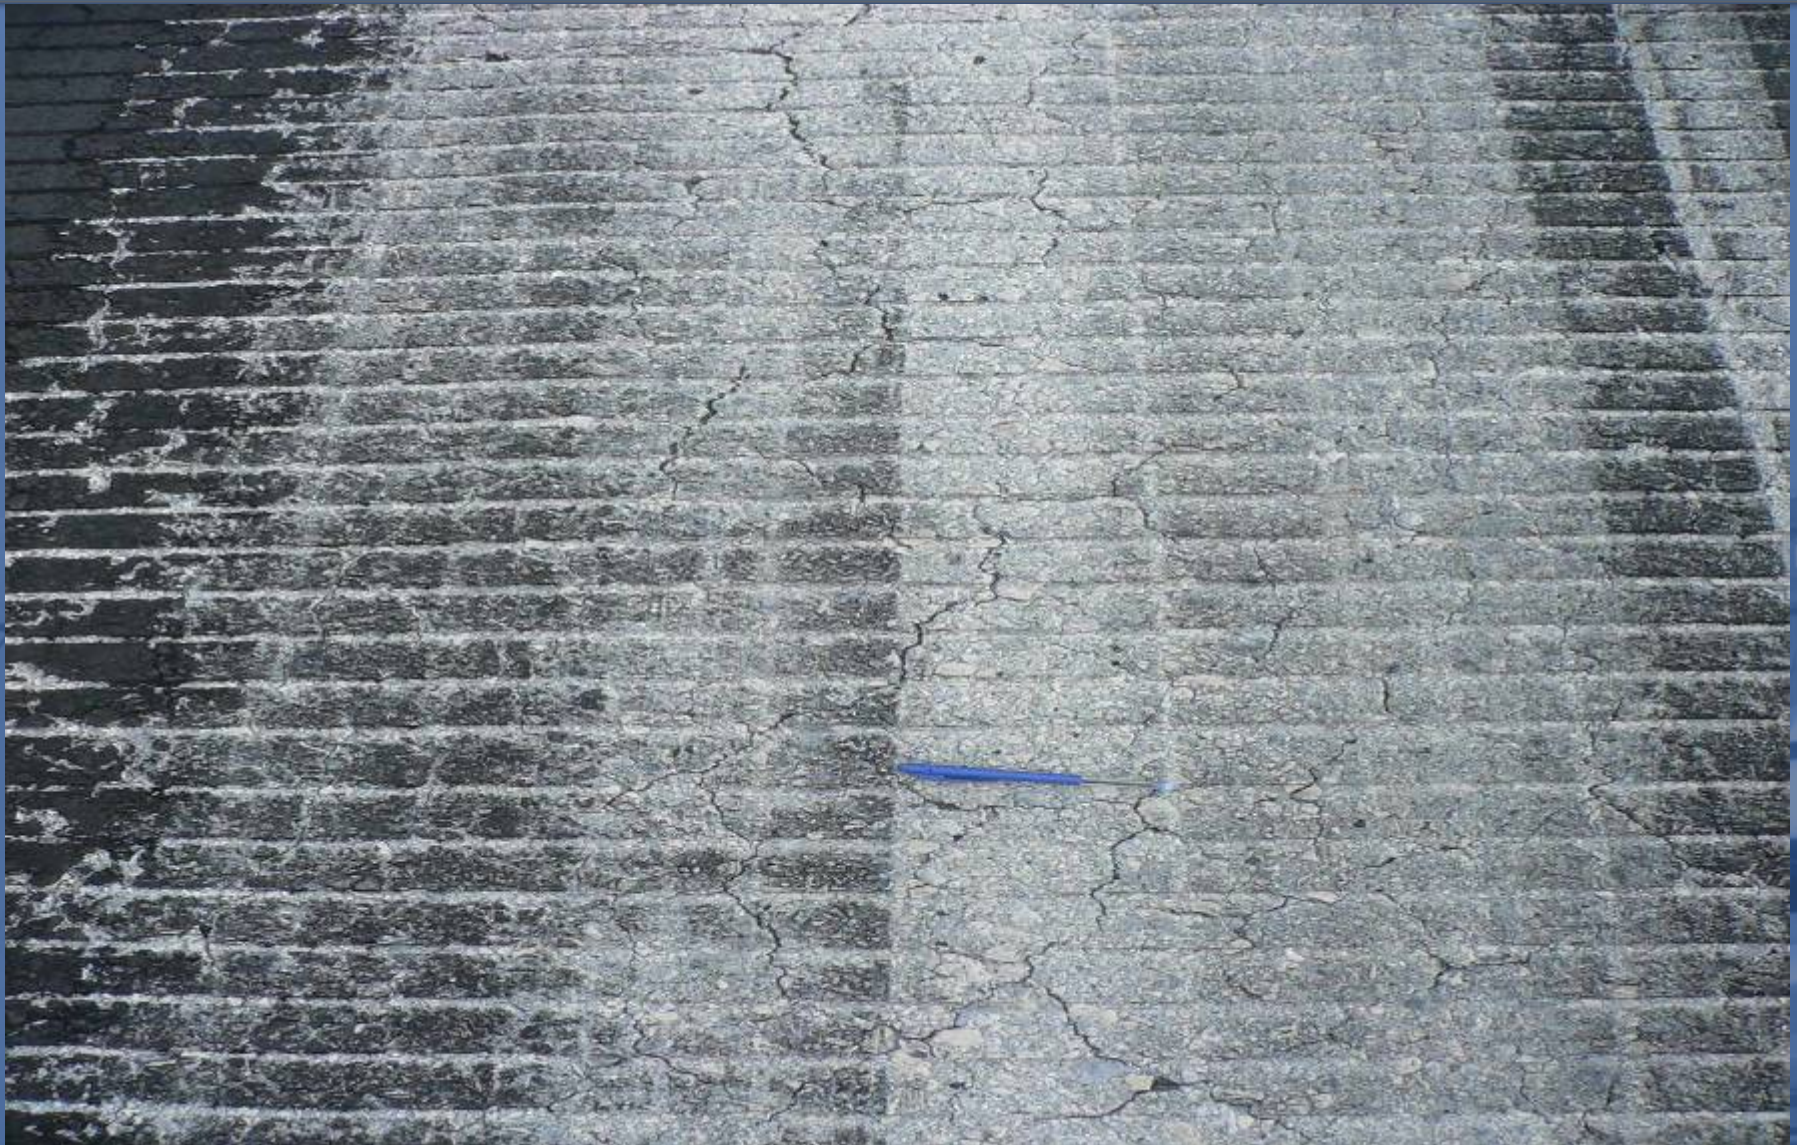
This surface area is located on Runway 7 where the majority of aircraft takeoffs and landings takes place

Cracks have increased, both in number and size

- For areas with severe raveling and cracking problems, contractor milled out a minimum of 50mm (2 inches) of the existing AC surface and replaced it with new AC prior to the new overlay surface
- If left untreated, the existing large cracks have the potential to reflect through the new AC overlay within 3-5 years

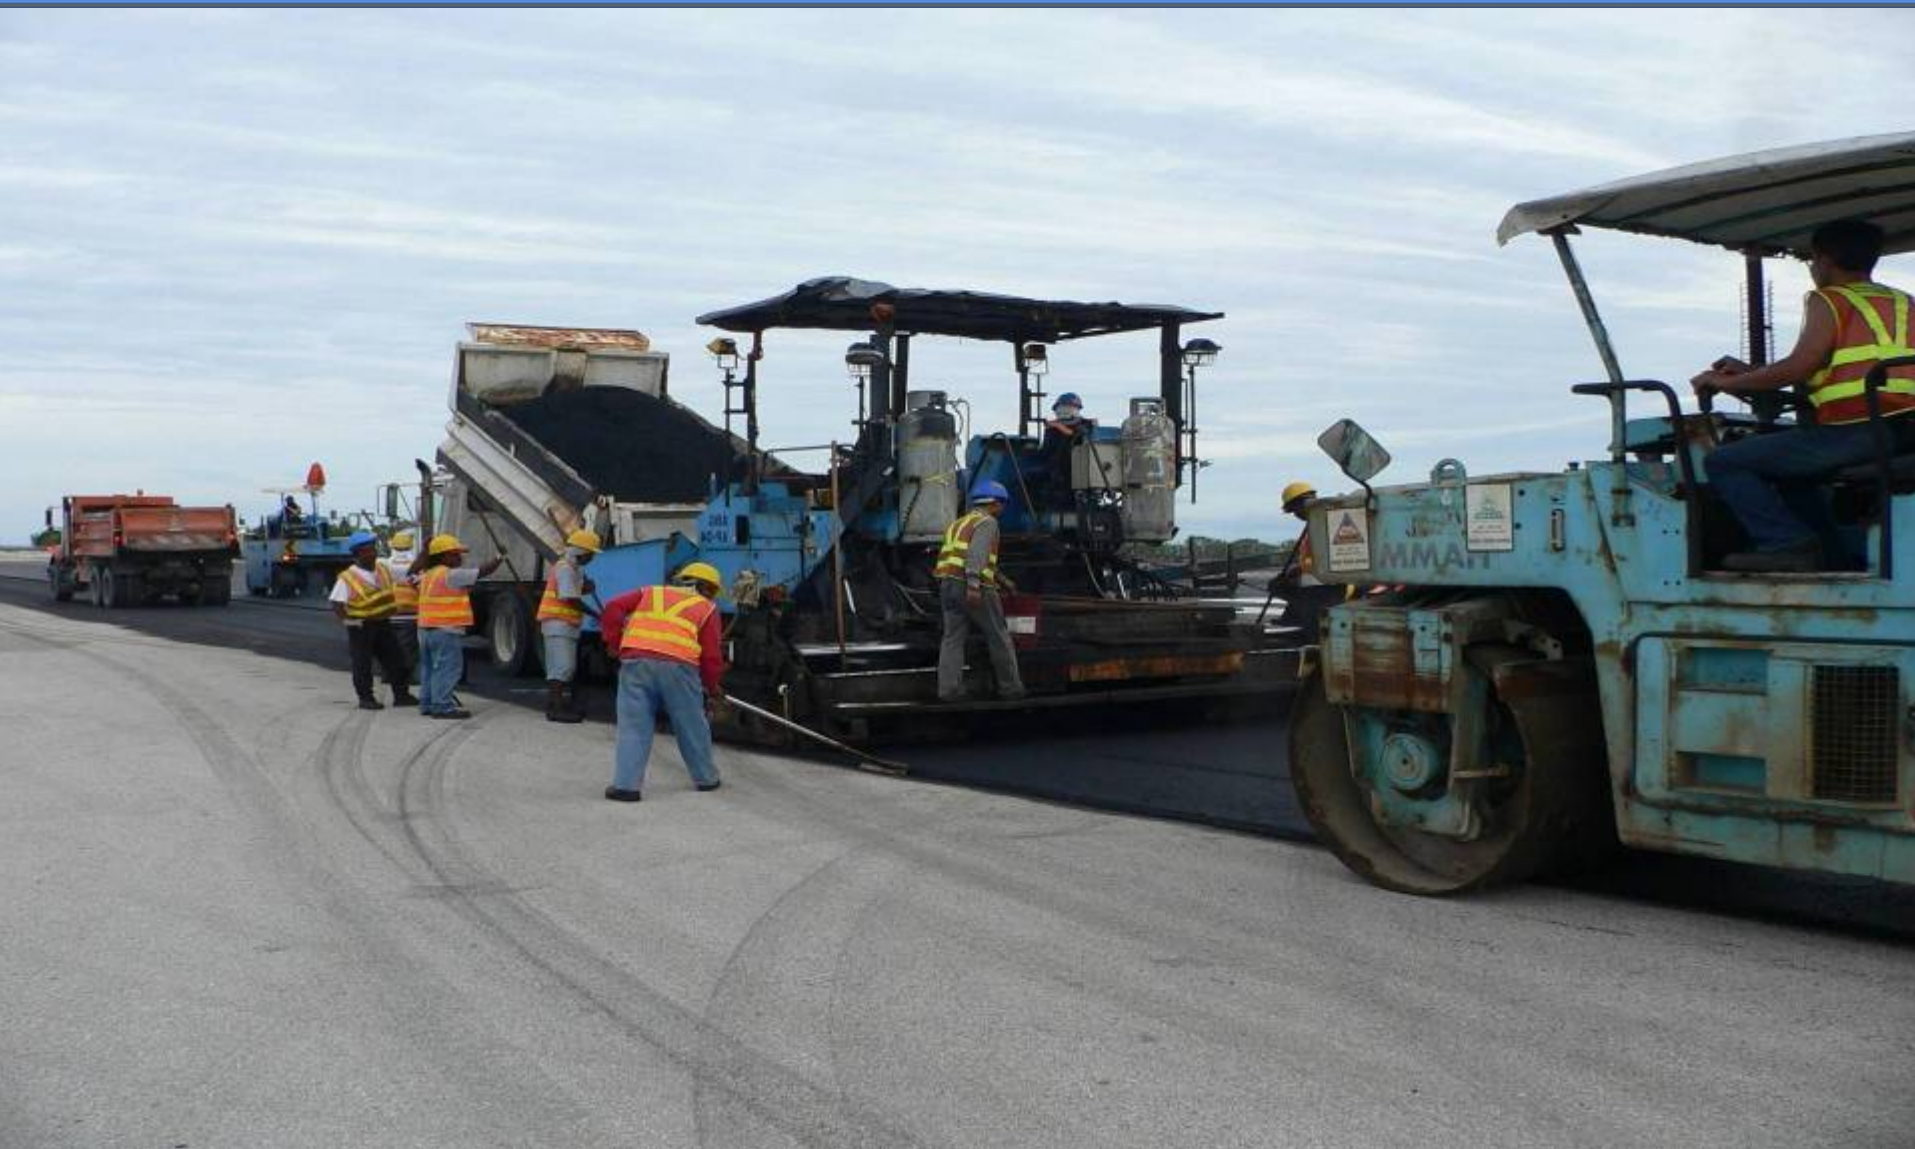
New Asphalt Overlay

- Size of Overlay Area: 8,300' x 150', and an additional 50' for shoulders (25' each side)
- Asphalt thickness varies from 3 to 6 inches

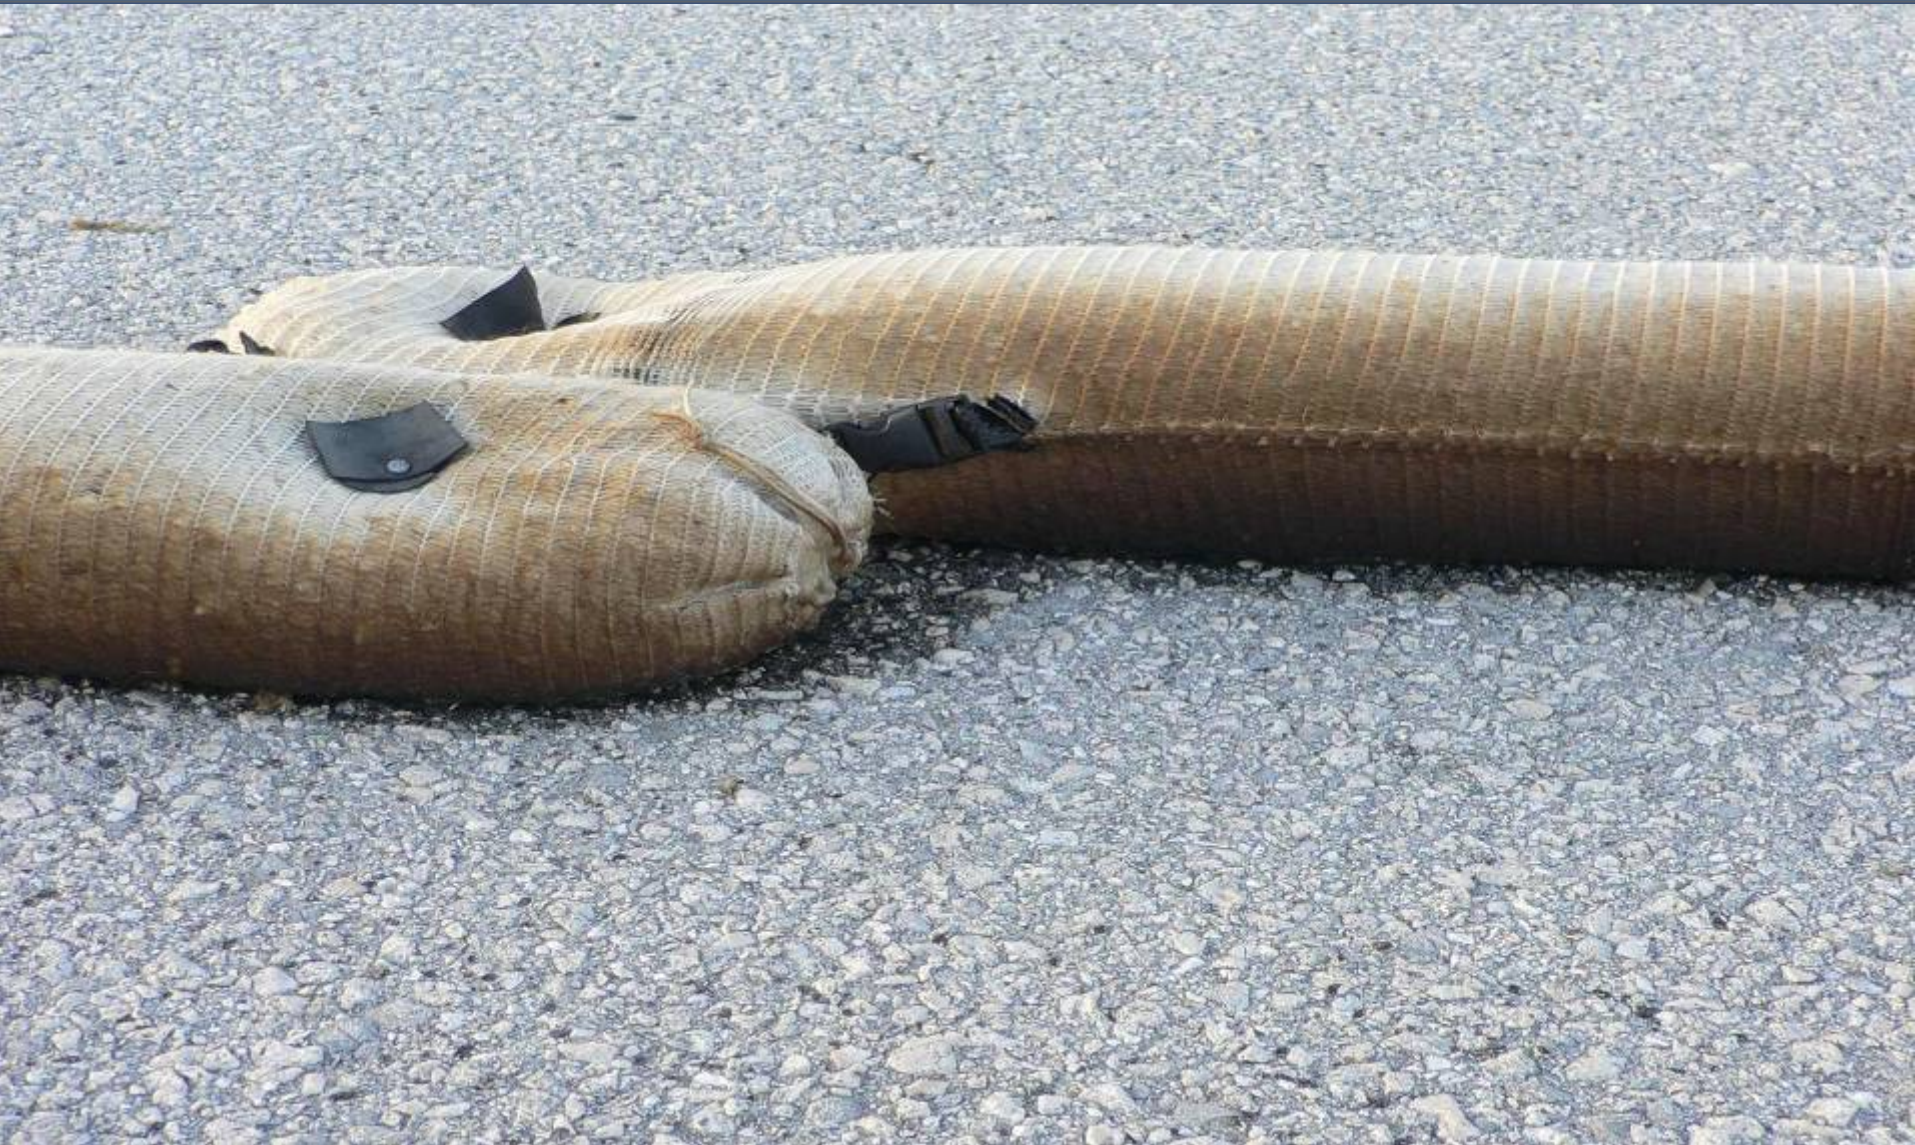
Spill Absorbent Booms

- A large quantity of the emulsion was absorbed by the booms, but some still reached the water catchment
- Procedure in place for heavy rain; local EPA to be contacted and pump to water reservoirs to be turned off
- EPA tested the water quality and gave the water catchment a clean bill of health

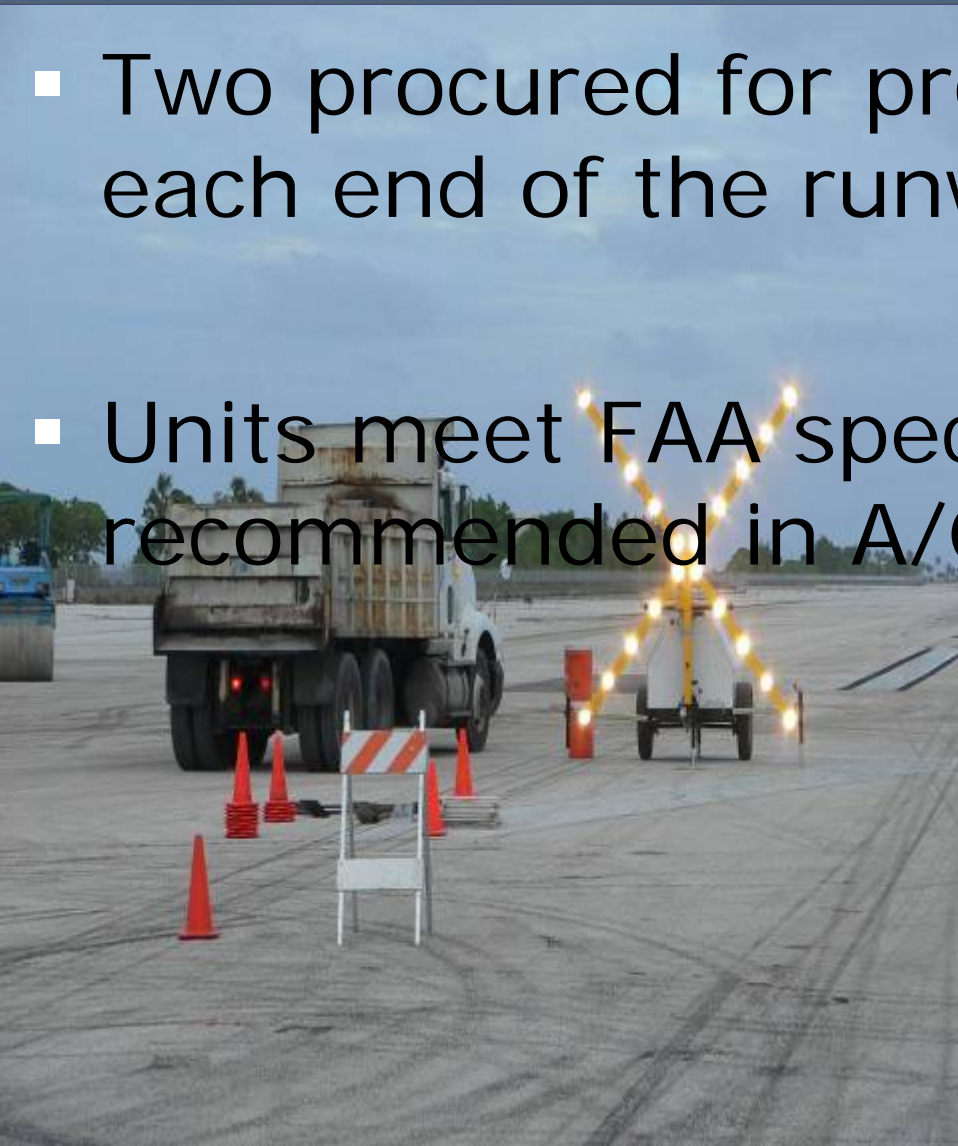
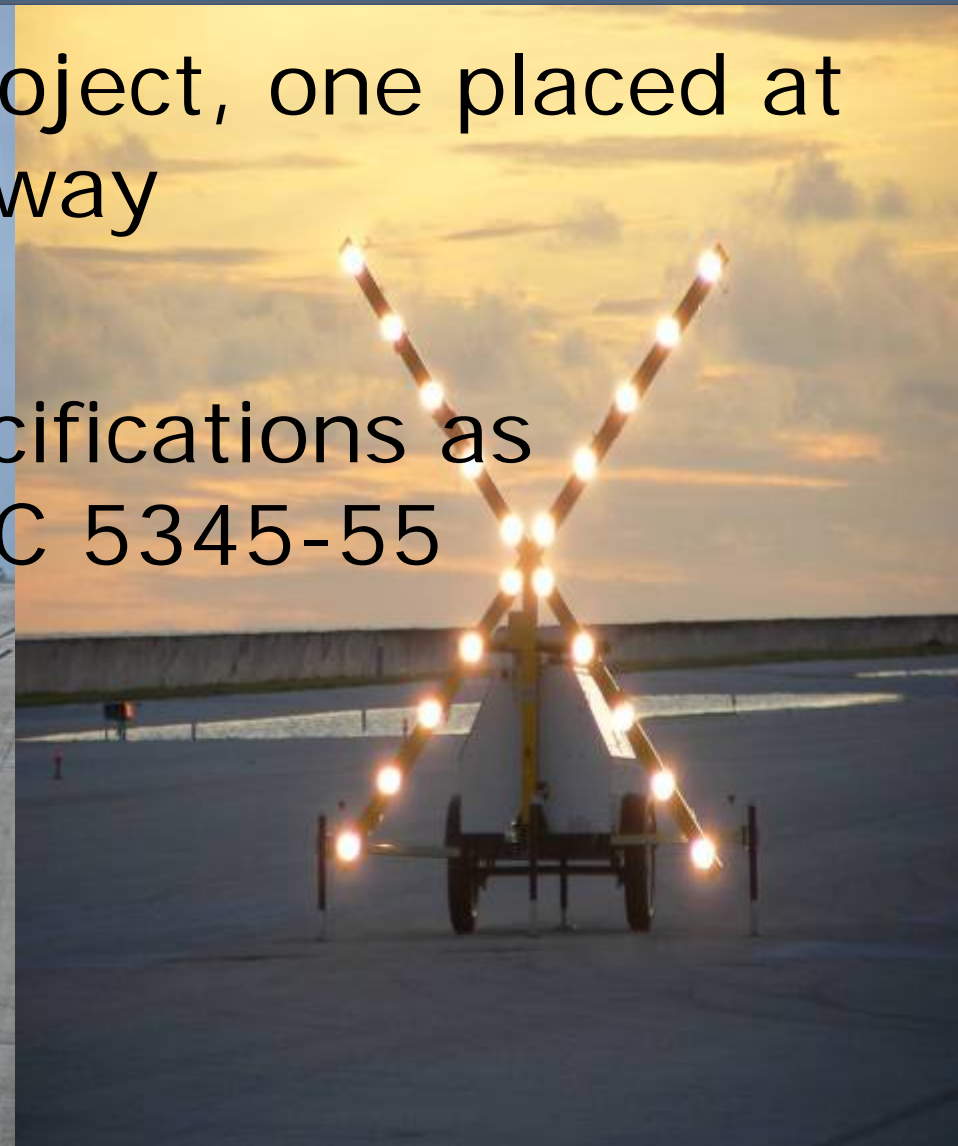
Lighted Runway Closure Xs

- Two procured for project, one placed at each end of the runway
- Units meet FAA specifications as recommended in A/C 5345-55

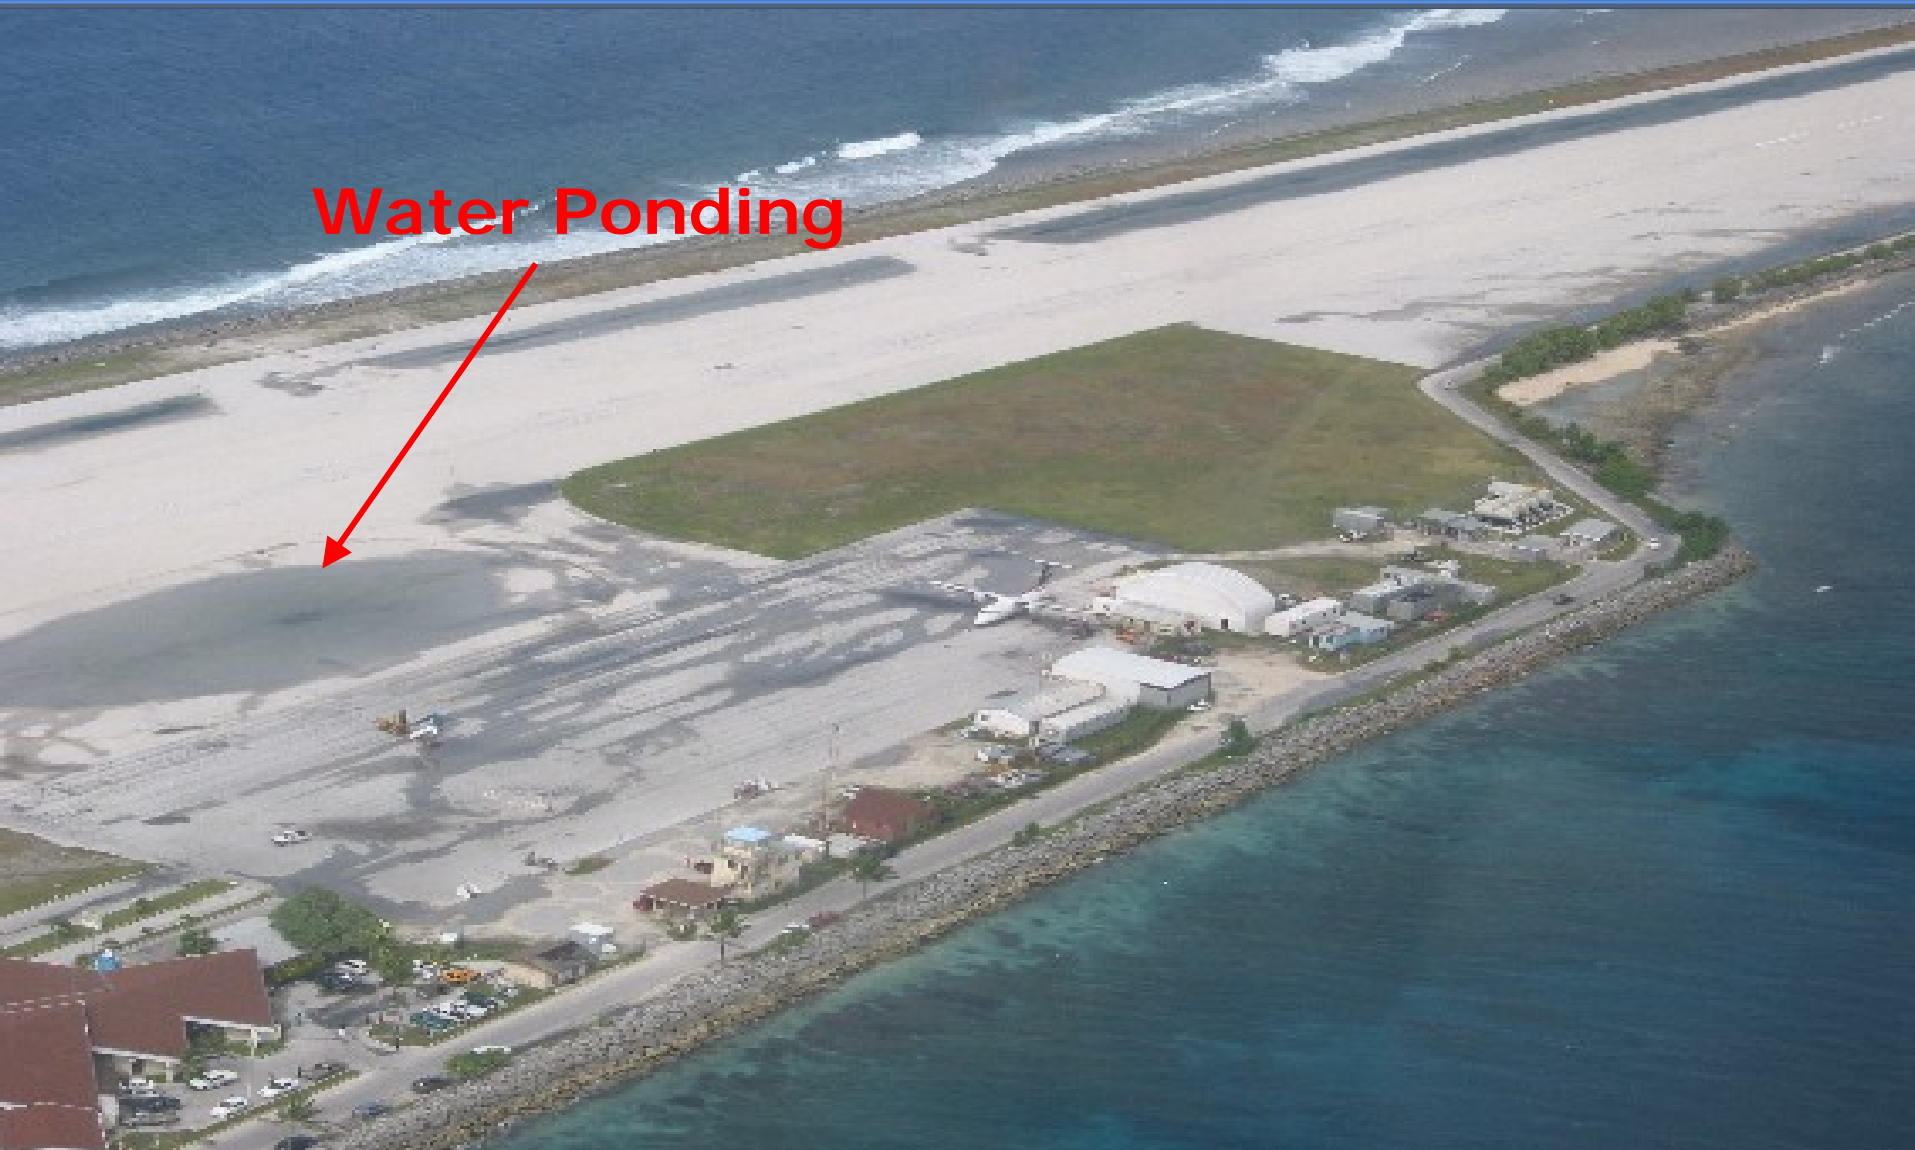
Water Ponding

- Summary of Scope of Works
 - Asphalt concrete overlay of the existing apron and taxiways
 - Upgrading of existing apron drainage systems to reduce water ponding
 - Construction of a concrete hardstand on the existing apron for aircraft refueling and loading

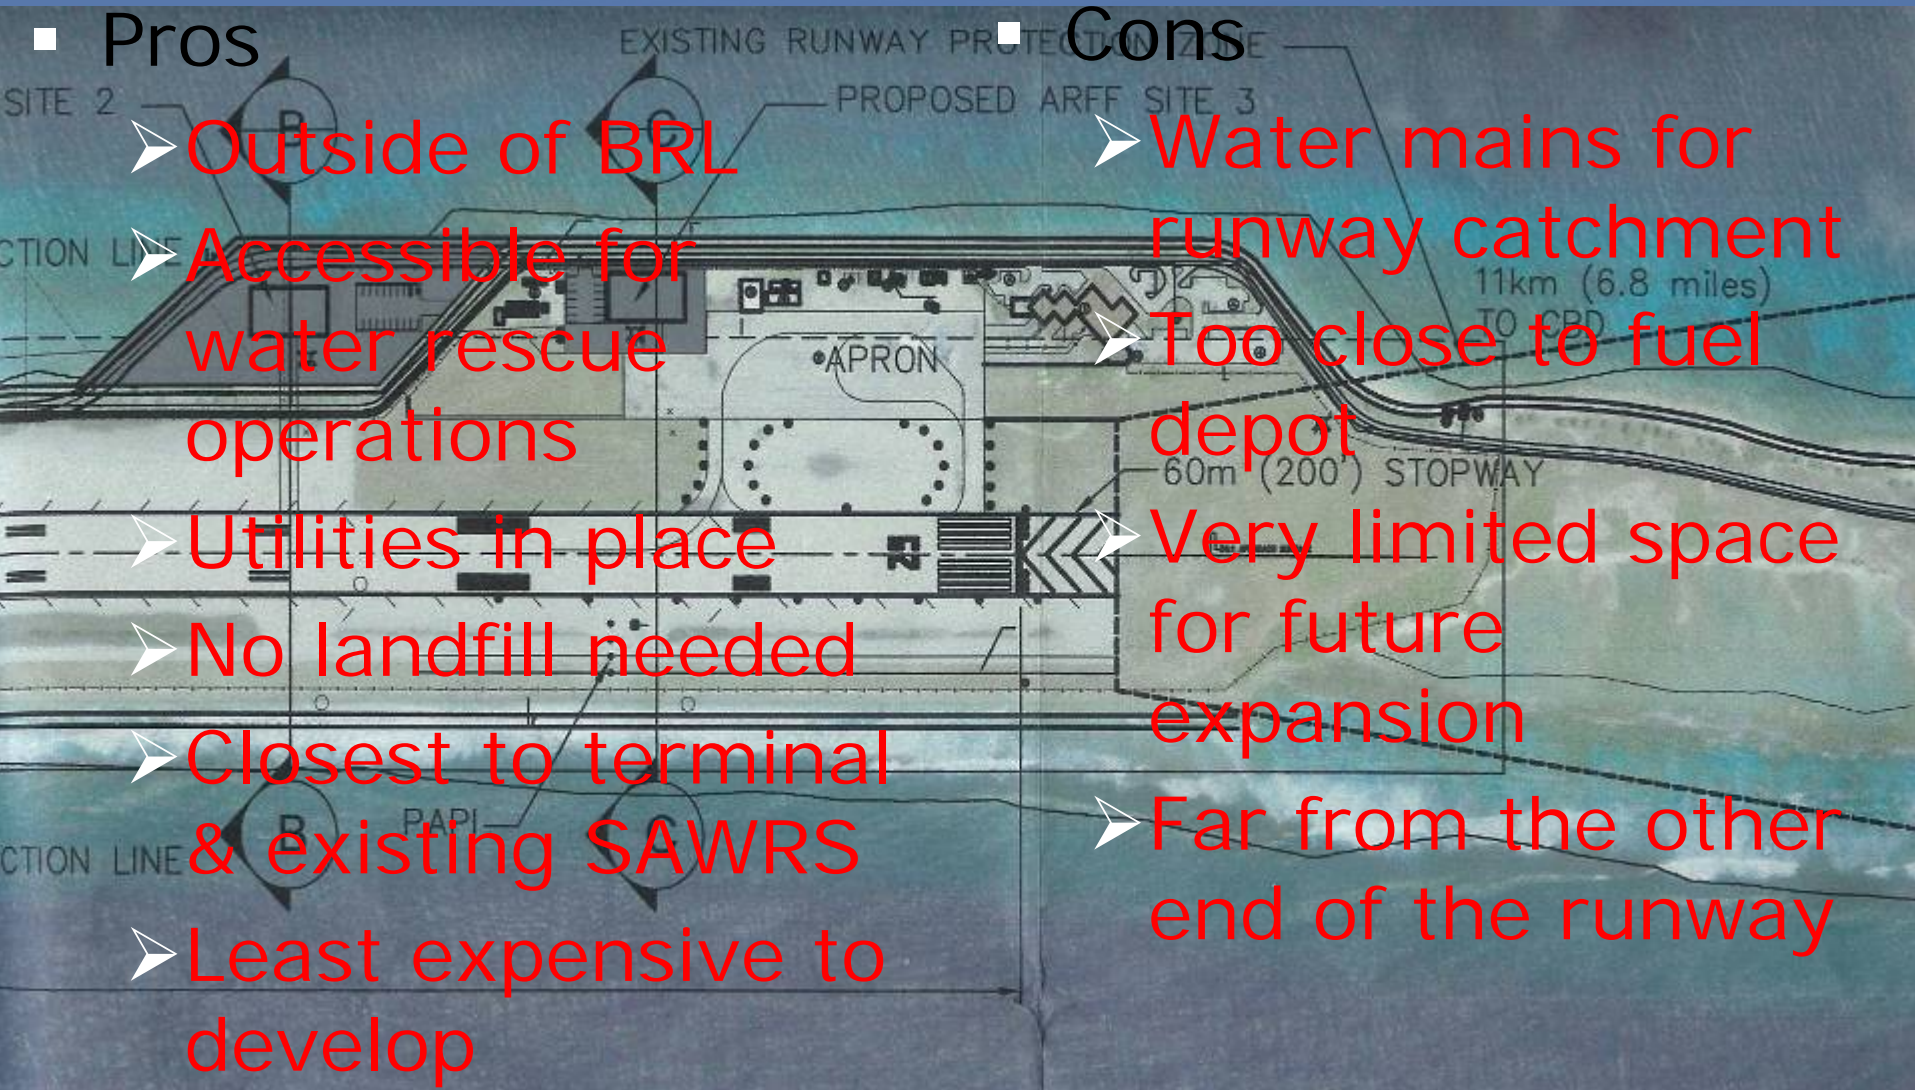
Site 3

- Outside of BRL
- Accessible for water rescue operations
- Utilities in place
- No landfill needed
- Closest to terminal & existing SAWRS
- Least expensive to develop

- Water mains for runway catchment
- Too close to fuel depot
- Very limited space for future expansion
- Far from the other end of the runway
